Marshall Space Flight Center Space Shuttle Knowledge Sharing Forum

Solid Rocket Booster Lesson on Unintended Consequences

January 27, 2011

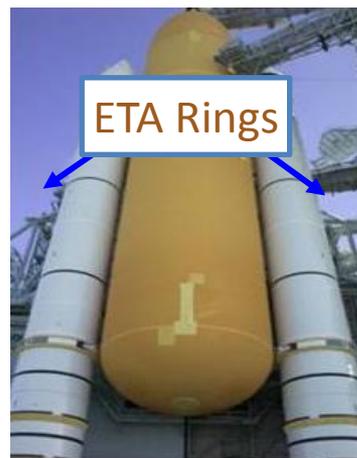
STA. 1511.0

ETA Ring Location

- Topic
 - External Tank Attach (ETA) ring material issue
- Story
 - Initial 4130 steel ETA ring spanned 270°
 - Redesignated ETA ring to 360° for STS-26
 - Modified existing hardware
 - Eliminated negative margins of safety during thrust build-up

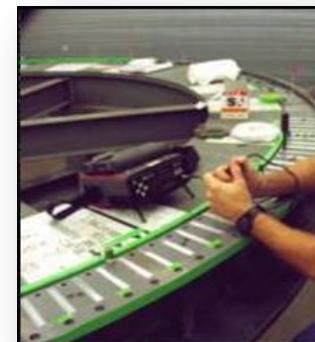
ETA Ring
Hardness Testing

ETA Ring Tensile Strength (ksi)		
	Yield	Ultimate
Test *	130-189	152-202
Requirement	163	180
* Performed on ETA Ring S/N 13

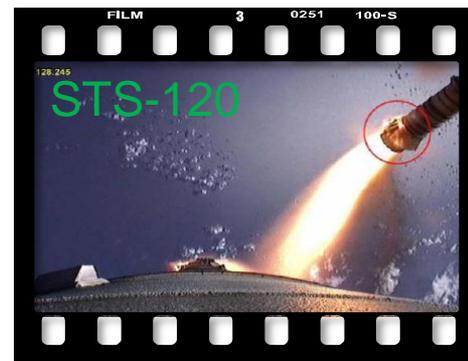
Aft Skirt Bluing
12-85-01

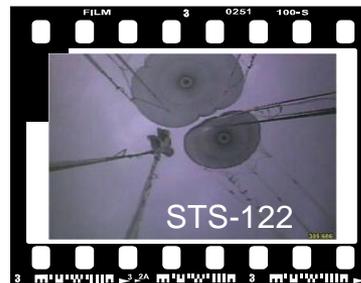
Parachute Failure

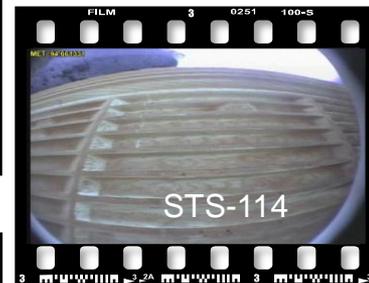
Hypalon Off Gassing

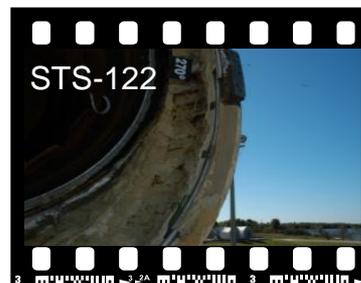
Hardwater impact

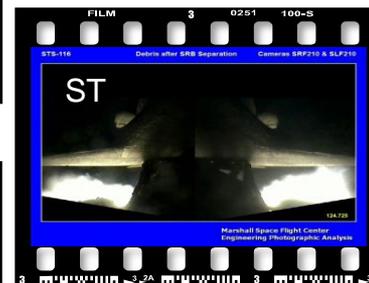
BTA from Aft BSM Hits Orbiter
